Additional Test report
Relating to the Fire
Resistance Performance
Of Six Specimens Of Wall
Mounted And Six
Specimens Of Floor
Mounted Linear Gap
Sealing Systems, Tested
In Accordance With BS
EN 1366-4: 2006

187564

Firestopit Limited

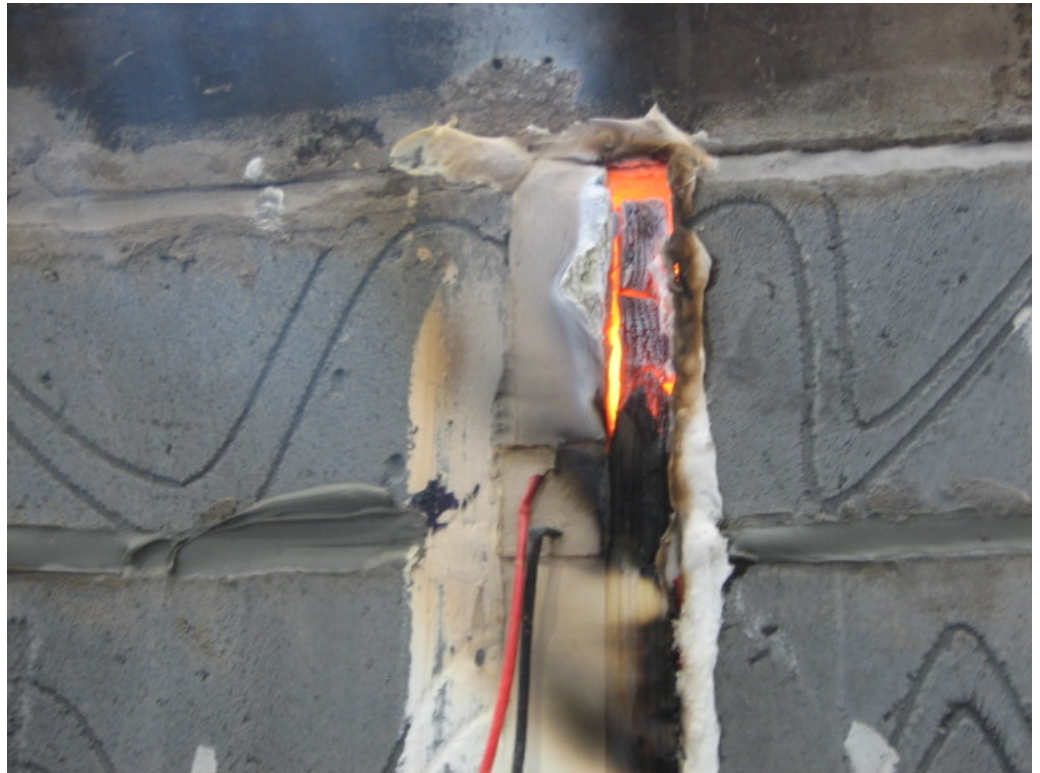
Integrity failure of Specimen J after 143 minutes of testing

Time		
mins	secs	
141	00	An area of glowing can be seen at the head of Specimen J as the timber substrate begins to burn through. A cotton pad is applied but fails to ignite.
142	35	Flickers of flames can now be at the head of Specimen J as the timber substrate continues to burn through.
143	10	A cotton pad is applied at the head of Specimen J and ignites. On removal of the pad a sustained flames is evident from the same location. Cotton pad and sustained flaming integrity failure of Specimen J is deemed to occur. The specimen is blanked off to allow the test to continue.
145	00	Thermocouple number 68 of Specimen I records a temperature rise in excess of 180° C. Insulation failure of Specimen I is deemed to occur.
155	00	Smoke release increases from Specimens E and F.
163	00	The steel angle substrate to Specimen L begins to bow away from the furnace chamber at the head of the specimen.
183	00	A cotton pad is applied to an area mid span of Specimen F but fails to ignite.

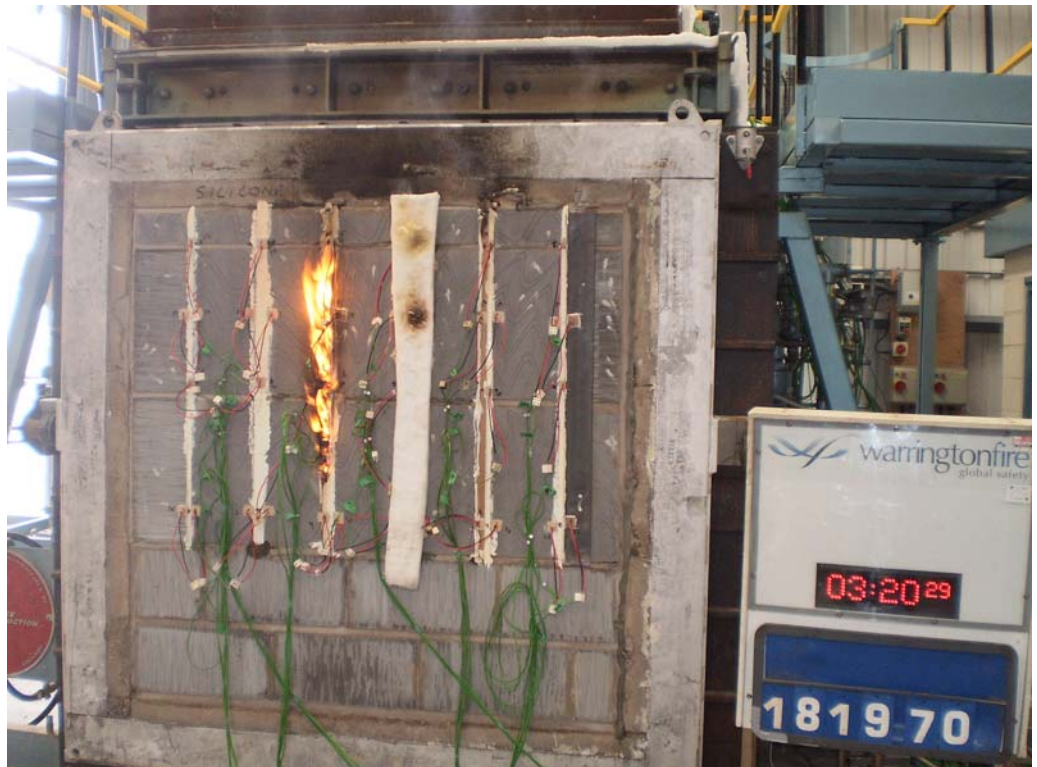
Integrity failure of Specimen I that occurred after 199 minutes of testing

186	00	Thermocouple number 23 of Specimen B records a temperature rise in excess of 180° C. Insulation failure of Specimen B is deemed to occur.
197	00	A cotton pad is applied to an area mid span of Specimen F but fails to ignite.
199	45	A sustained flame spreads throughout Specimen I as the timber substrate burns through and ignites. Cotton pad and sustained flaming integrity failure of Specimen I is deemed to occur. The specimen is blanked off to allow the test to continue.
208	20	A sustained flame is visible at the head of Specimen K as the timber substrate burns through and ignites. Cotton pad and sustained flaming integrity failure of Specimen K is deemed to occur. The specimen is blanked off to allow the test to continue.
210	00	The surface thermocouples of Specimen H are temporarily exposed to hot furnace gasses venting from behind the blanking material of Specimen I.
229	00	A cotton pad is applied to Specimen F along steel edge and ignites. Cotton pad integrity failure of Specimen F is deemed to occur. The heat radiating from the steel substrate of Specimen F was the cause of cotton pad integrity failure at this point.

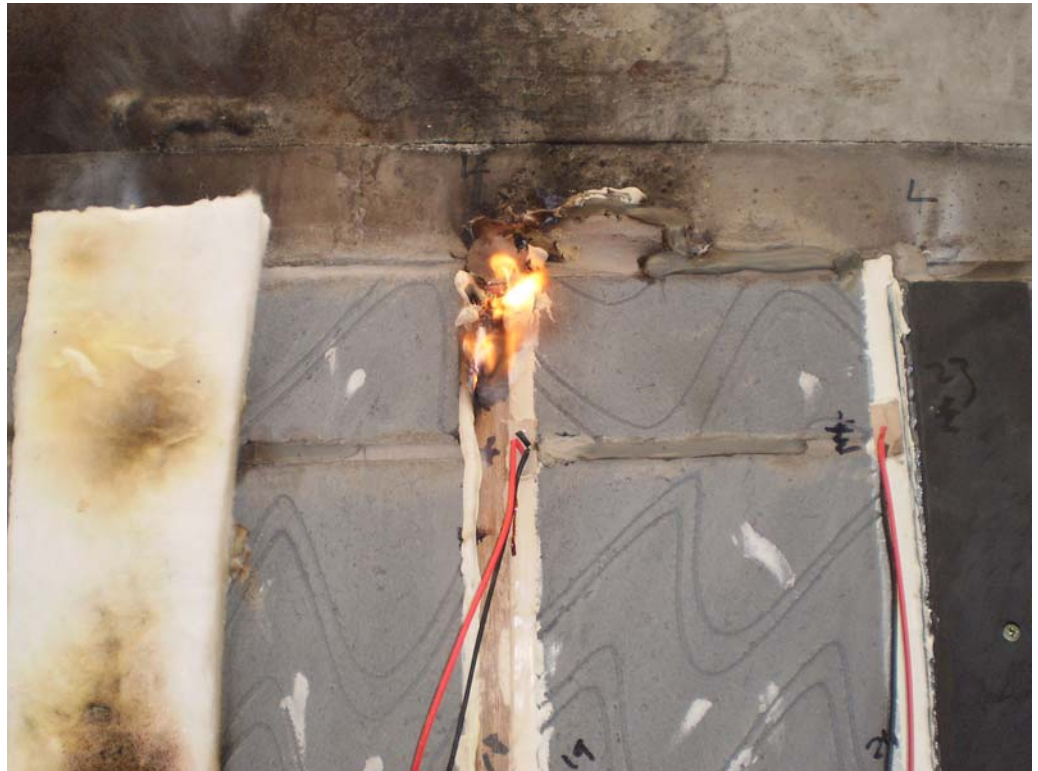
Integrity failure of Specimen K after 208 minutes of testing

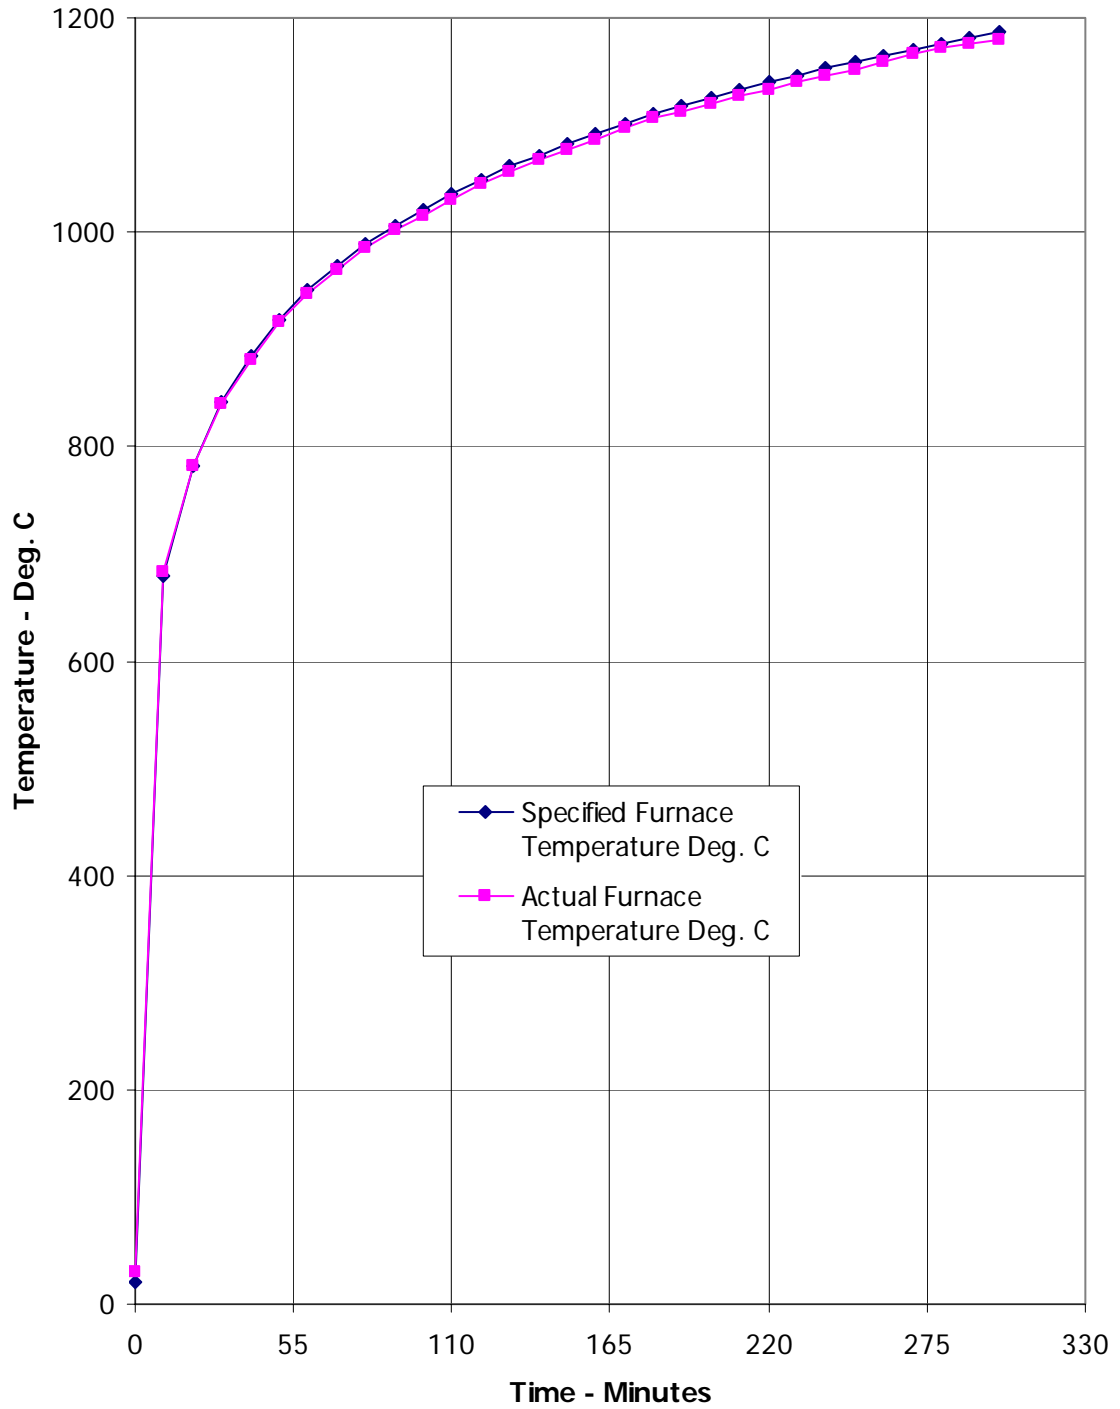
Graph Showing Mean Furnace Temperature, Together With The Temperature/Time Relationship Specified In The Standard

Time Mins	Specified Furnace Temperature Deg. C	Actual Furnace Temperature Deg. C
0	20	30
10	678	684
20	781	782
30	842	841
40	885	881
50	918	916
60	945	942
70	968	965
80	988	985
90	1006	1002
100	1022	1016
110	1036	1031
120	1049	1045
130	1061	1057
140	1072	1068
150	1082	1077
160	1092	1085
170	1101	1097
180	1110	1106
190	1118	1113
200	1126	1120
210	1133	1127
220	1140	1133
230	1146	1140
240	1153	1147
250	1159	1152
260	1165	1159
270	1170	1166
280	1176	1172
290	1181	1177
300	1186	1180
